# SPACE SHUTTLE AEROTHERMODYNAMIC DATA REPORT

DMS-DR-2515  
NASA-CR-167,684

POST-TEST DATA REPORT FOR THE SPACE  
SHUTTLE FULL-SCALE AFRSI SEQUENCE OF  
ENVIRONMENTS TEST (OS-305-1 TO -5)  
IN THE NASA/AMES RESEARCH CENTER  
11x11-FOOT WIND TUNNEL

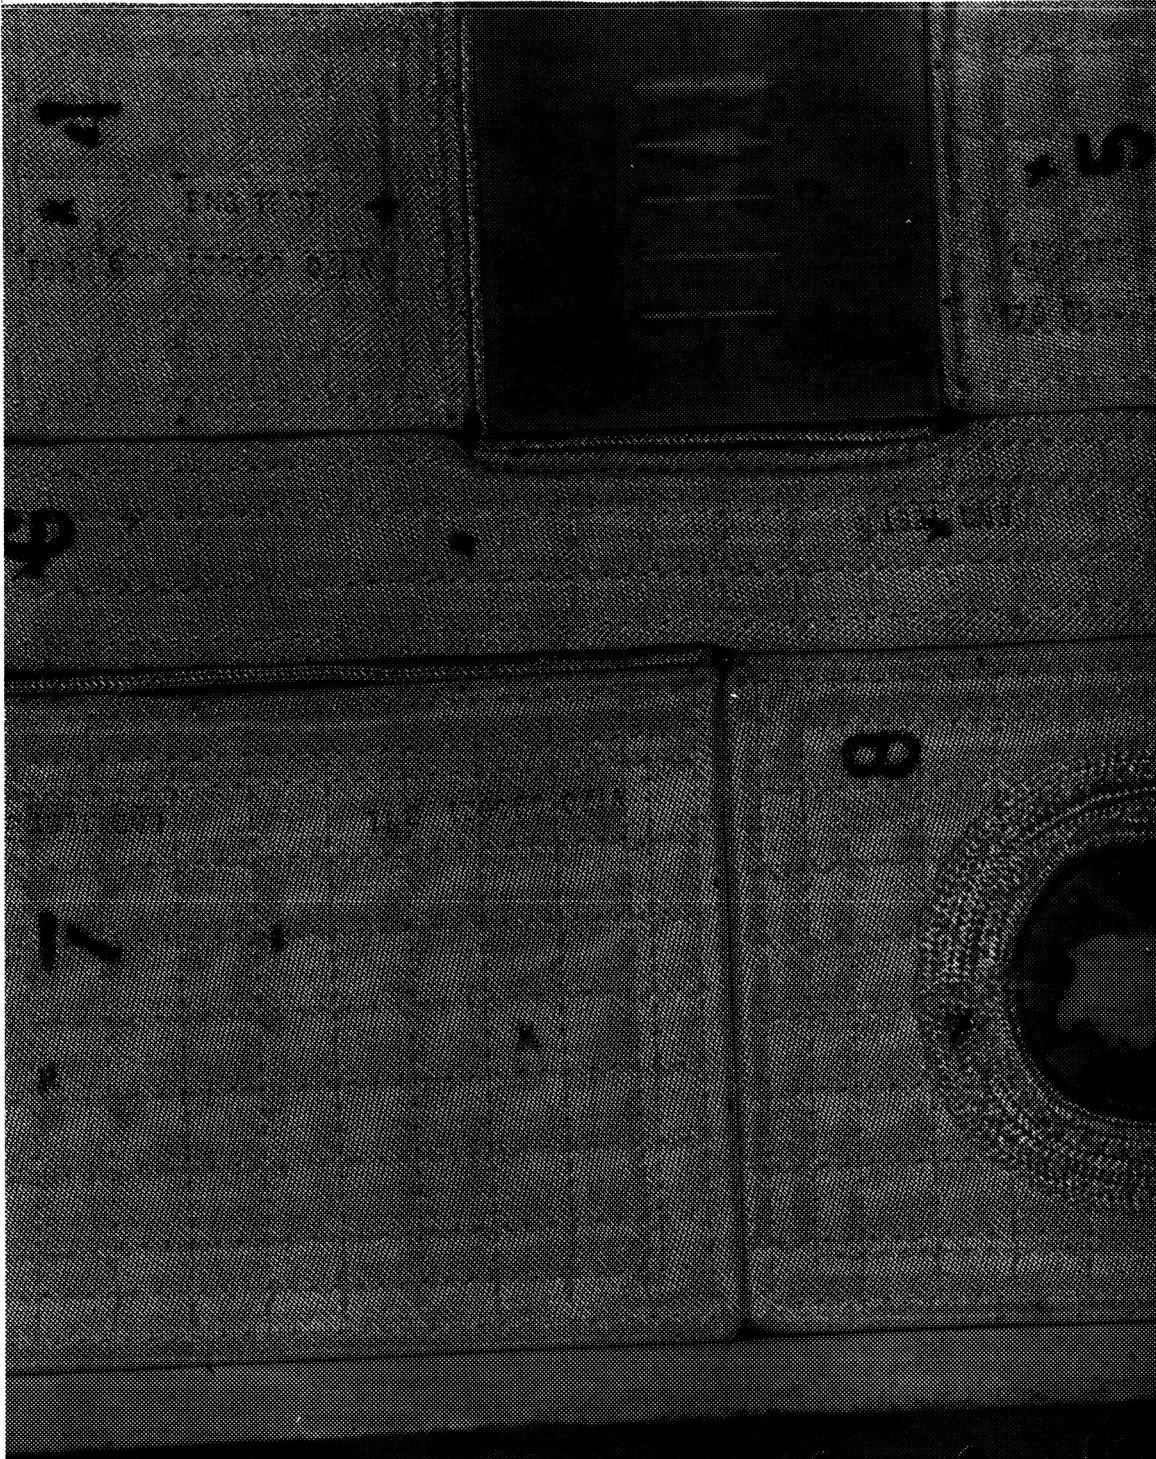
Figure 2 (Continued)

- i. Post-Test OS-305-2 close-up photograph of the aft portion of Model 125-0 (Test Article ND-14-4)

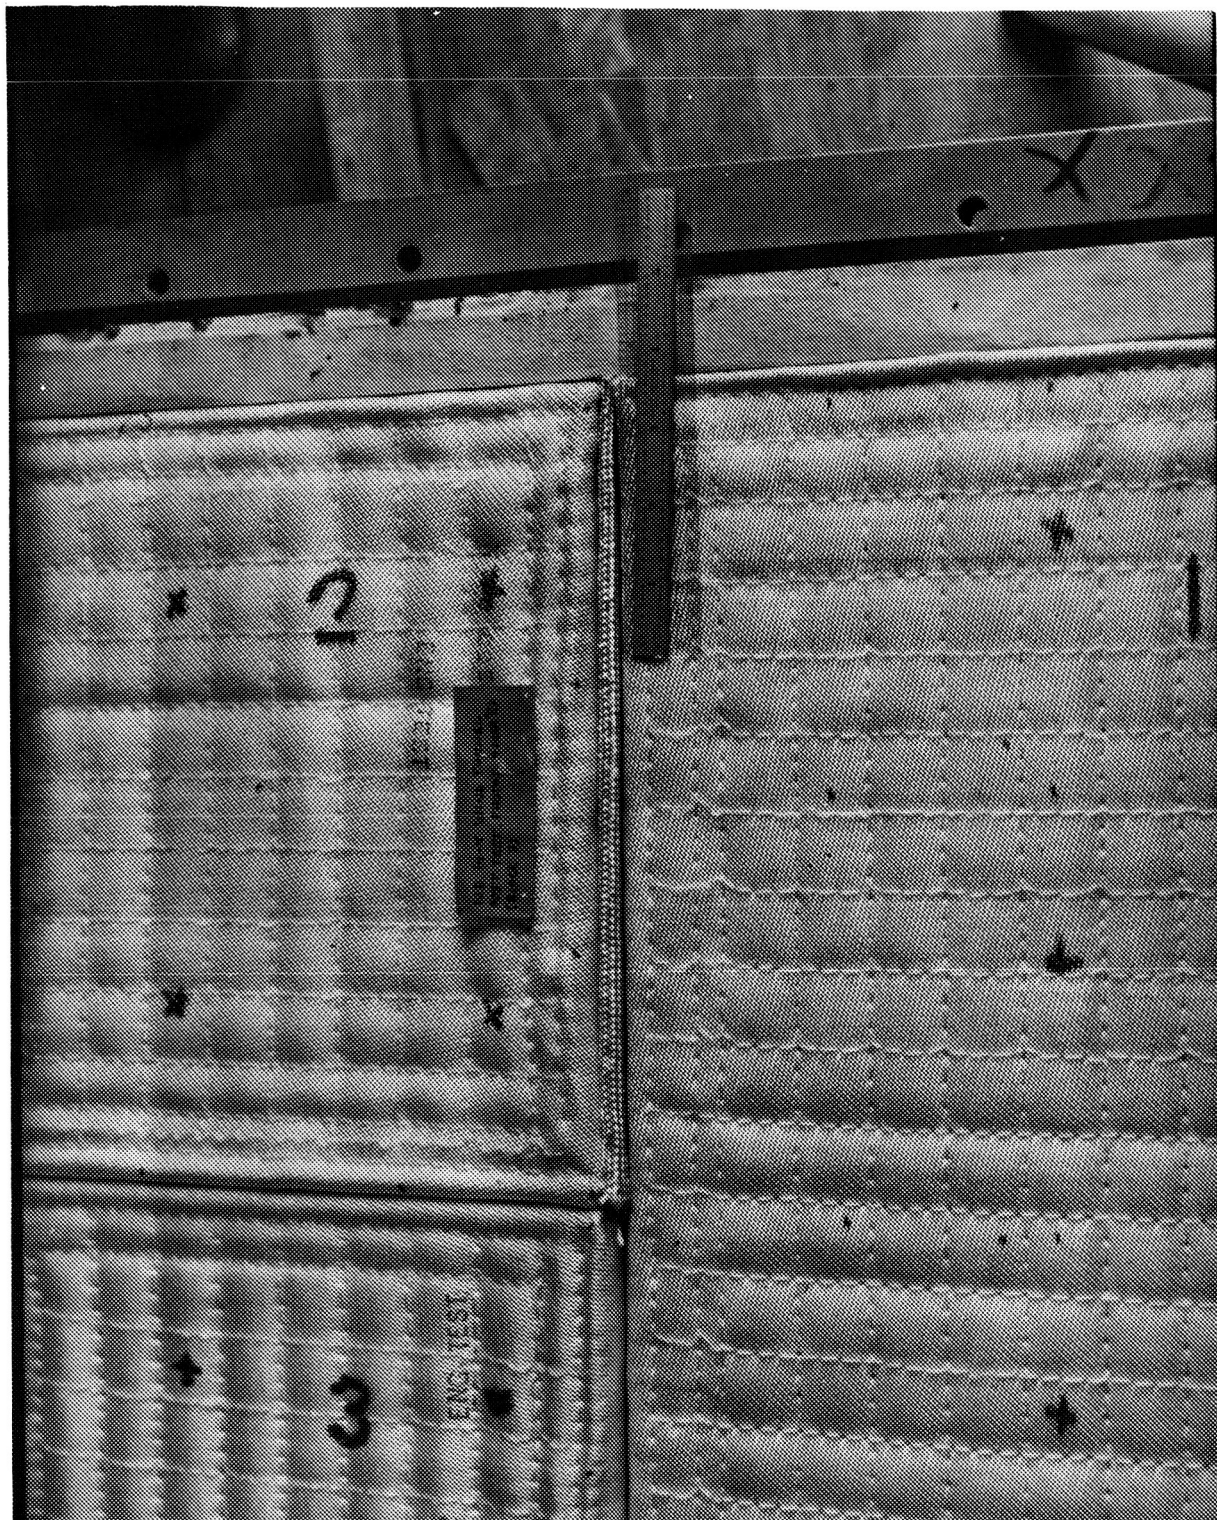
Figure 2 (Continued)

k. Post-Test OS-305-3 close-up photograph of the forward portion of Model 125-0 (Test Article ND-14-4)
